Maitai Dam

2013 Comprehensive Safety Review

26 June 2014

Prepared for Nelson City Council

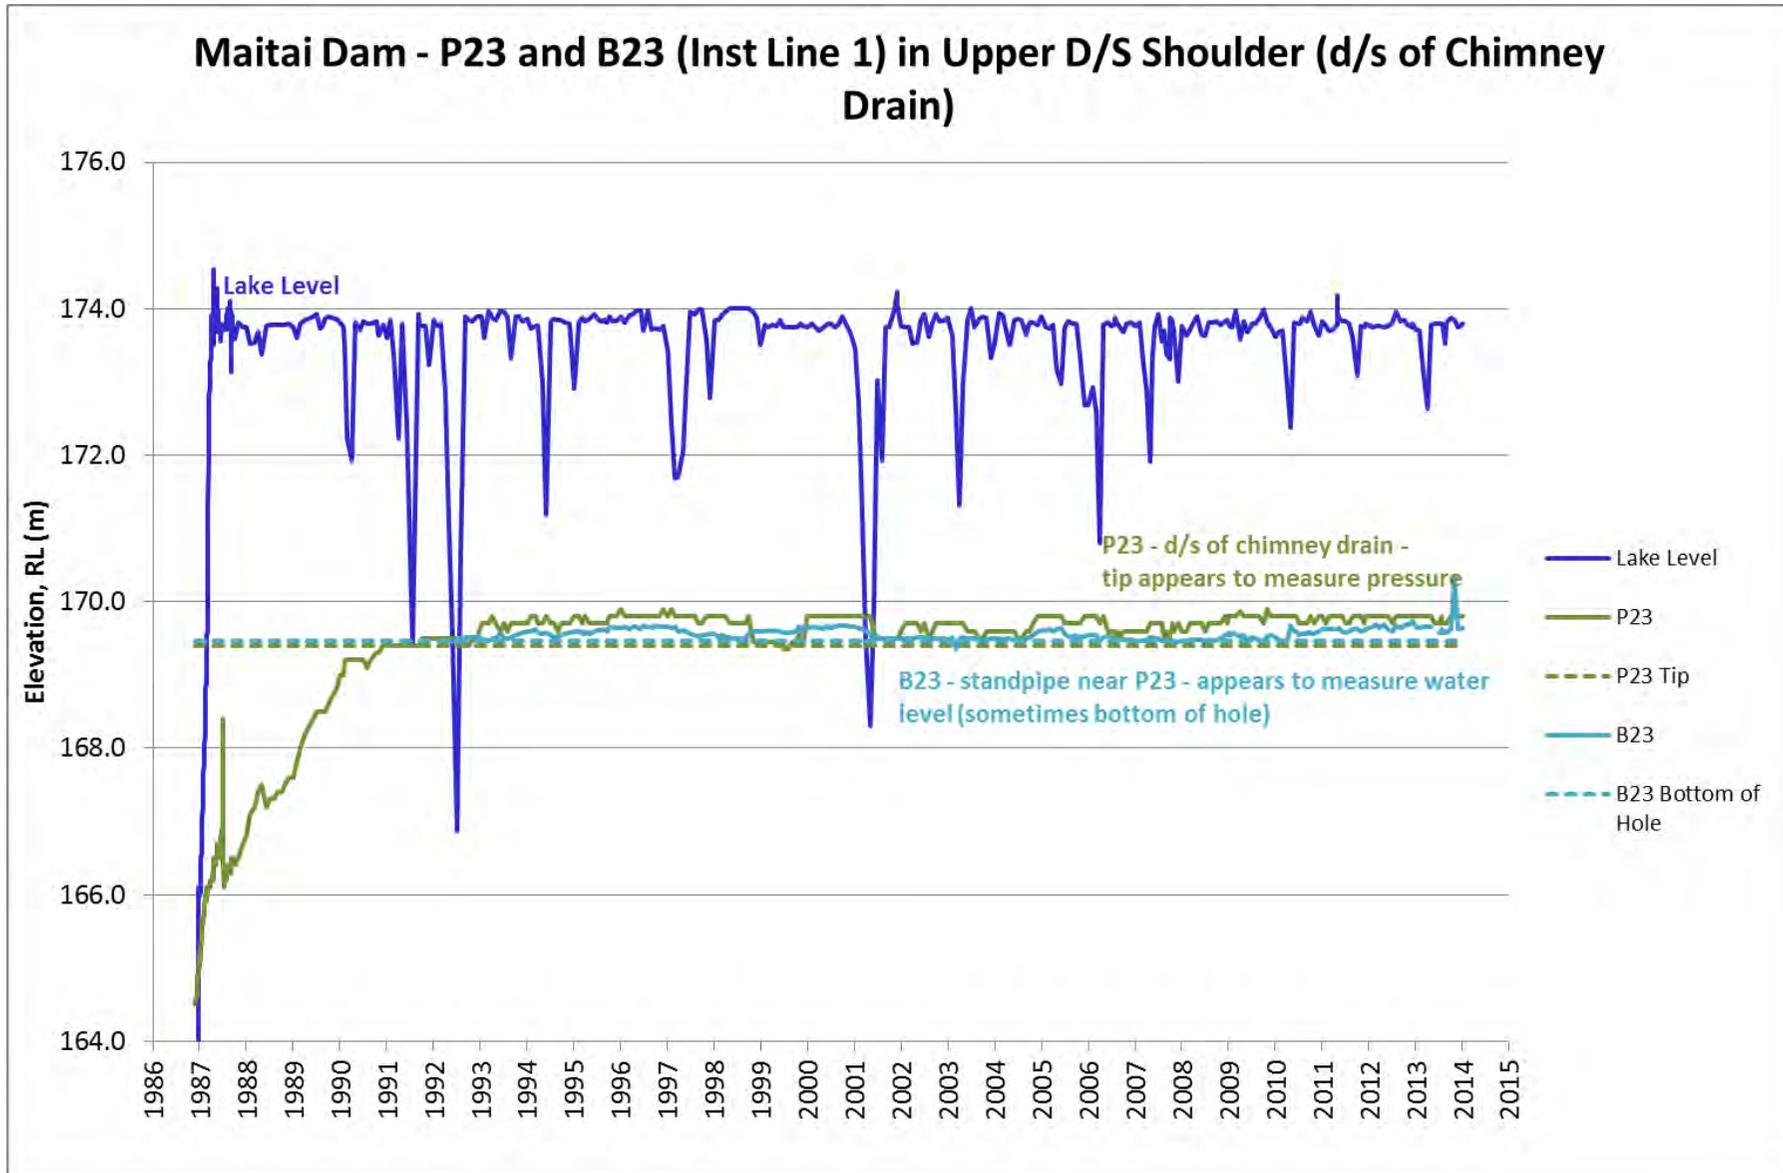
Figure 10: Maitai Dam – Piezometer Instrument Line 1 – P23 and B23 Upper Downstream Embankment (1986-2014)

| No. | Recommendation | Report Ref. | Priority |
|---|---|---|---|
| 11 | It is recommended that as-built location and installation details for B23 and B27 be confirmed and indicated on a drawing for the purpose of ongoing data evaluation. | 7.3.2 | B |
| 12a | It is recommended that the purported water pressure in the upper embankment downstream of the chimney drain be thoroughly investigated and resolved. This should include an assessment of the reliability of the instruments and measured data, and consideration given to supplementary monitoring in this location. | 7.3.2 | A |

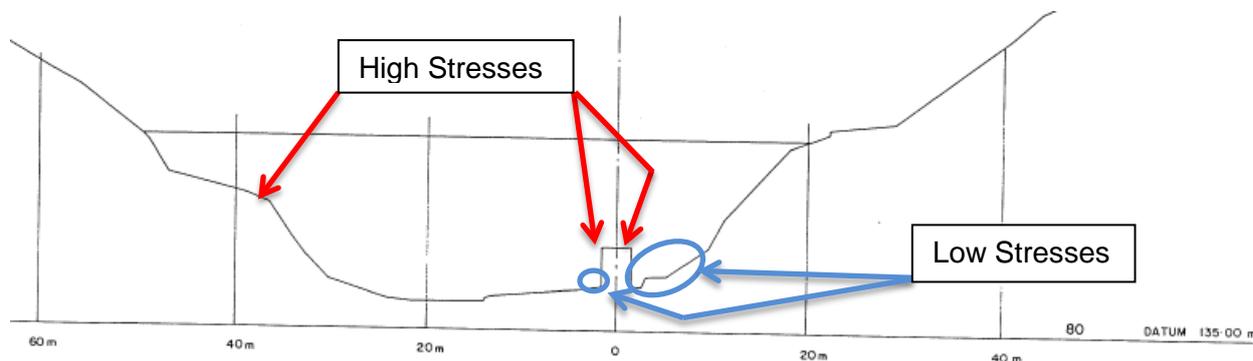
The culvert penetration and its geometry within the embankment results in areas of high and low stress concentrations for differential settlement and cracking to likely occur. The culvert geometry from upstream to downstream is shown on the foundation profile drawings. The sharp corners of the culvert create areas of high stress concentrations while the corners at the culvert base result in areas of low stresses. The potential for differential settlement and transverse cracking also depends on compaction obtained along the culvert. Construction documents state fill material along the culvert was well compacted using hand equipment. The upstream 14 culvert bays, however, include plywood panels placed on the sides. The long-term implications of the plywood on the contact of fill against the culvert needs to be considered when evaluating ongoing performance of the dam for cracking and internal erosion.

Figure 23: Areas of High and Low Stresses along Maitai Dam Foundation, Section 80

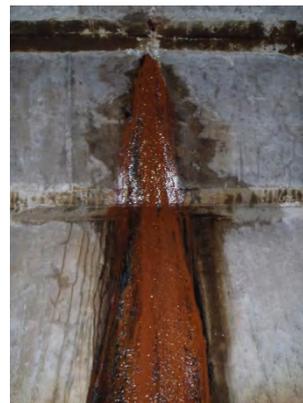
Photo 18: Culvert Leakage and Bacterial Growth

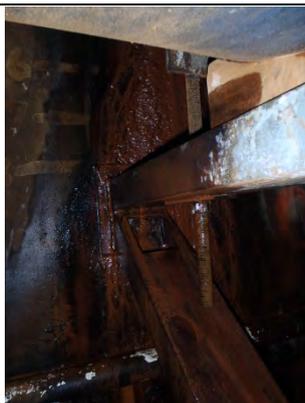
Photo 19 Culvert Leakage and Bacterial Growth on Pipe Bracket

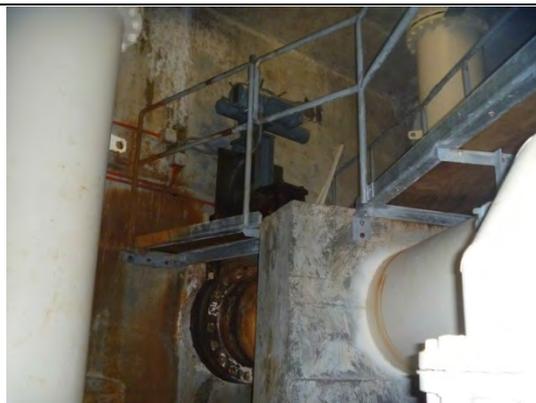
Photo 20 Valve Chamber Rust from Leakage on Scour Pipe

| No. | Recommendation | Report Ref. | Priority |
|---|---|---|---|
| 7 | It is recommended the rusted pipework be cleaned and repainted. | 6.1 | C |

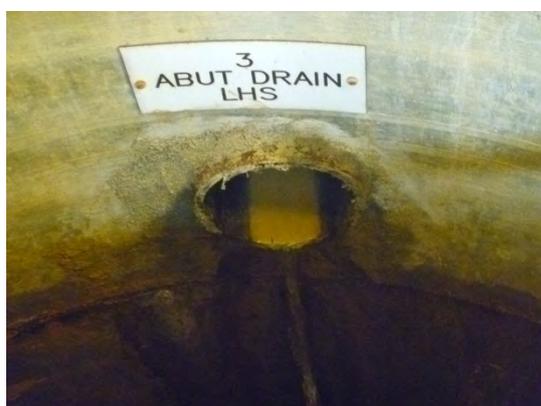
Photo 21: Seepage Emerging from L.H.S. Abutment Drain

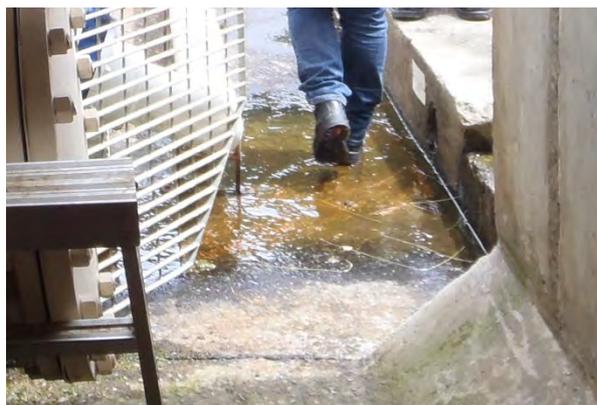
Photo 25: New Leakage at Downstream Culvert Area and Exit Drain

| No. | Recommendation | Report Ref. | Priority |
|---|---|---|---|
| 8 | It is recommended that seepage emerging adjacent to the culvert be monitored with documentation on its development. | 6.1 | A |

| No. | Recommendation | Report Ref. | Priority |
|---|---|---|---|
| 15 | It is recommended the right exit area drain be checked for damage or blockage in regards to the new seepage observed (ref: Rec-08). | 7.3.3 | A |

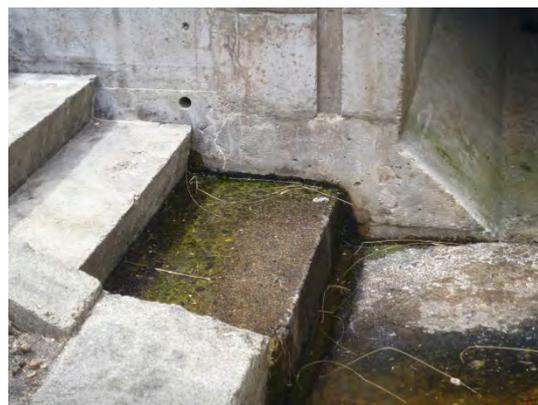
Photo 26: New Leakage at Right Side of Downstream Culvert Area

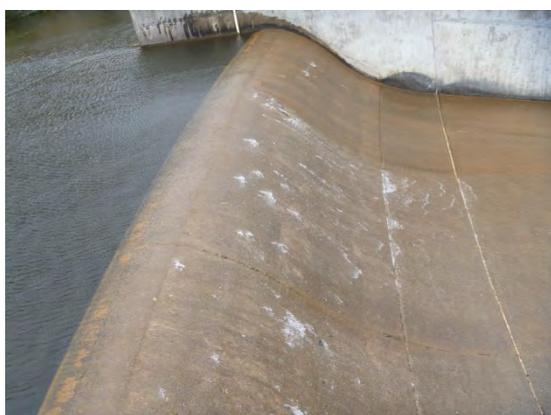
Photo 27: Service Spillway Ogee Crest, Rough Surface Areas

| No. | Recommendation | Report Ref. | Priority |
|---|---|---|---|
| 9 | It is recommended the repairs are made to ensure a smooth finish on the chute floor of the service spillway. | 6.1 | C |

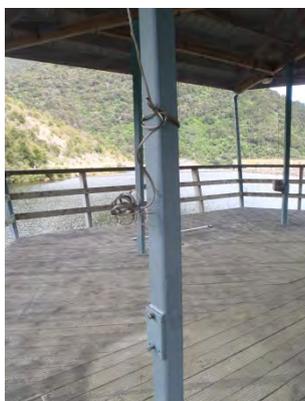
Photo 44: Intake Tower Platform and Missing Screen Hoist

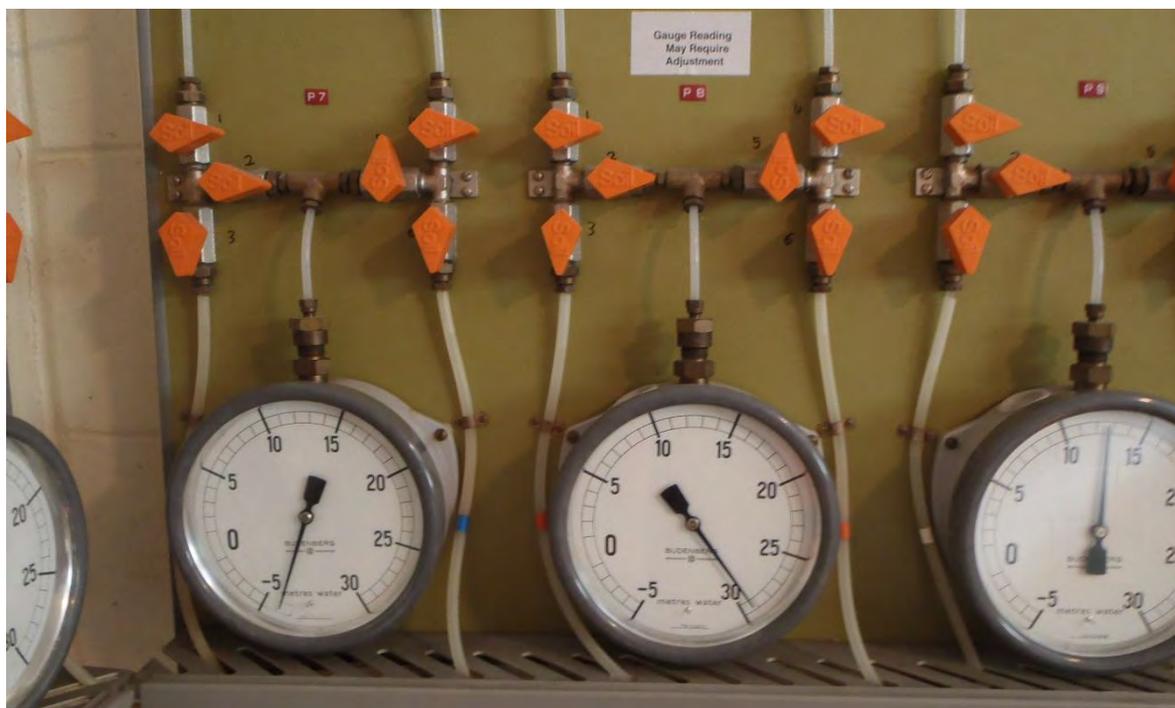
Notwithstanding this, gauges for P7 and P8 were reading beyond the limits of the gauge (see photo below taken in April 2013).

Figure 1 - Photograph of gauges showing P7 below the lower bound of the gauge and P8 close to the upper limit.

| No. | Recommendation | Report Ref. | Priority |
|---|---|---|---|
| 12b | It is recommended all piezometer gauges should be calibrated to be accurate in their respective normal reading ranges. | 7.3.2 | B |

We recommend that the upcoming CSR consider whether the pressures measured by P7 and P8 are reflective of the expected pressures at these locations. The gauges themselves appear to be fully functional (see above) and options to make these gauges more useful may include replacement with gauges more appropriate for the expected operating range of the respective piezometers (i.e. extending lower than -5 m H₂O for P7, and a -5 to 40 m H₂O range for P8 - similar to that used for P10).
