Maitai Dam

2013 Comprehensive Safety Review

26 June 2014

Prepared for Nelson City Council

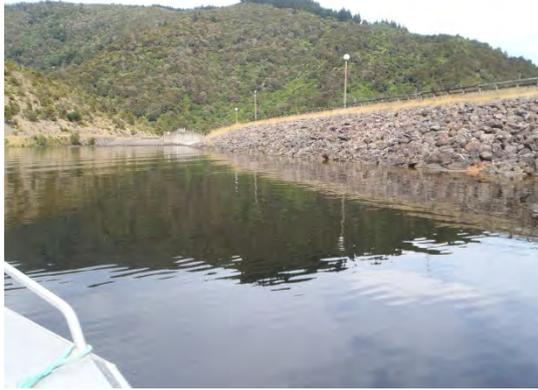
Photo 27: Upstream Embankment Slope (L.H.S.)

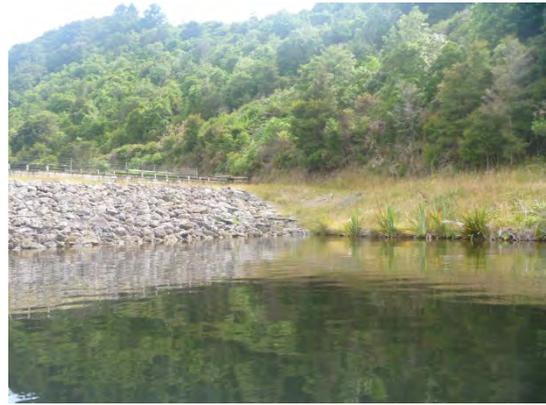
Photo 28: Upstream Embankment Slope (R.H.S.)

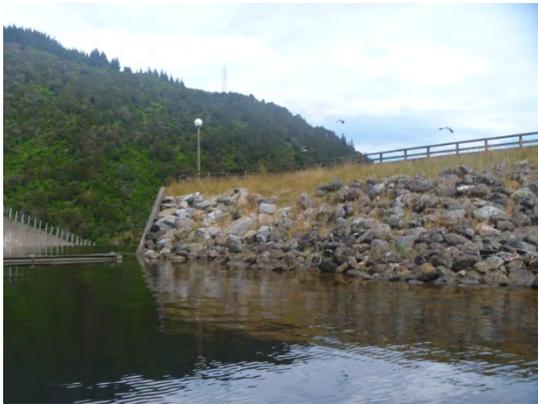
Photo 3: Upstream Embankment Slope, Near Service Spillway

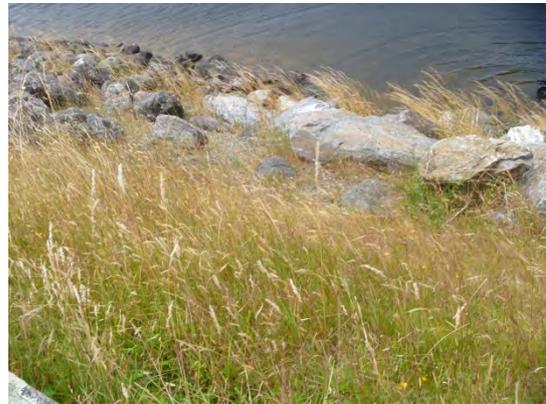
Photo 4 Upstream Embankment Slope, New Rip-Rap

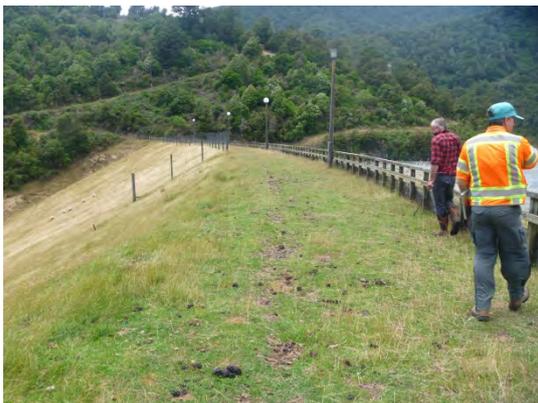
Photo 5: Dam Crest

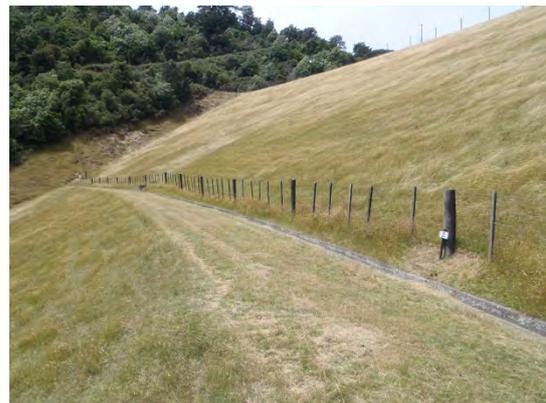
Photo 6: Downstream Toe Buttress Berm

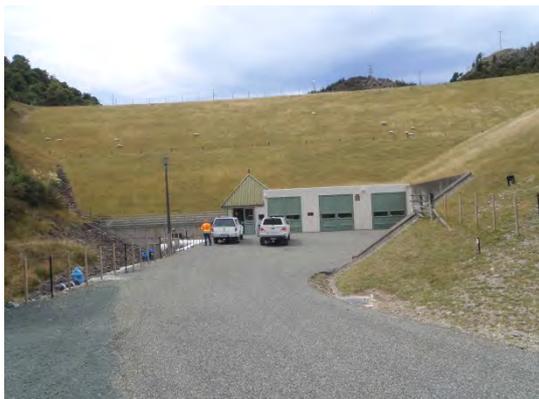
Photo 7: Downstream Slope and Control Building

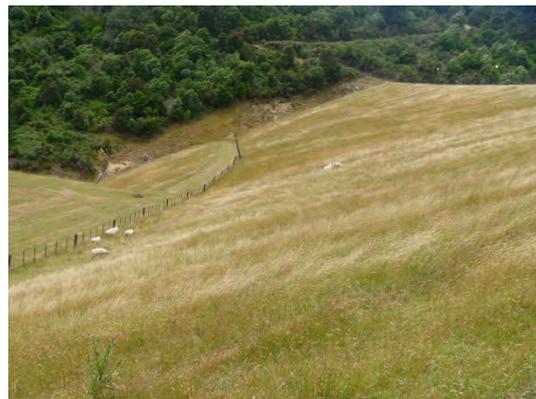
Photo 8: Downstream Slope, Looking at Right Abutment

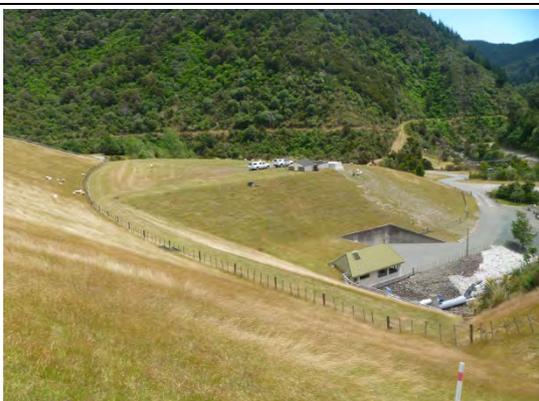
Photo 9: Downstream Slope, Looking at Left Abutment

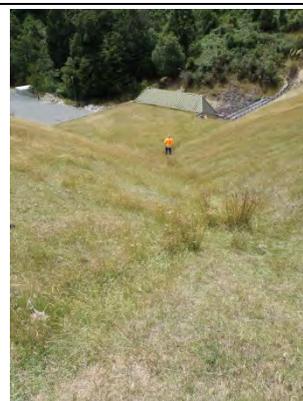
Photo 10: Left Abutment Groin with Scattered Reeds

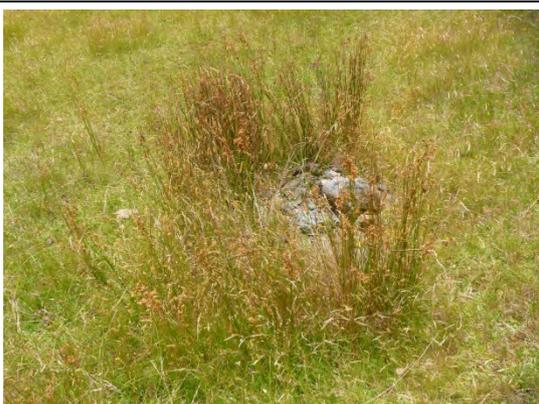
Photo 11: Reeds at Corner of Toe Buttress Berm and Left Abutment Groin

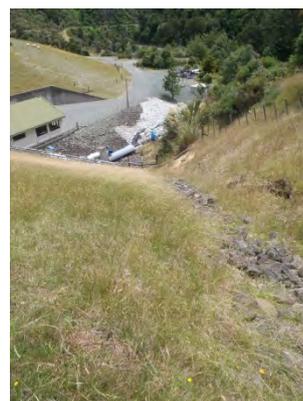
Photo 12: Right Abutment Groin with Drainage Rock

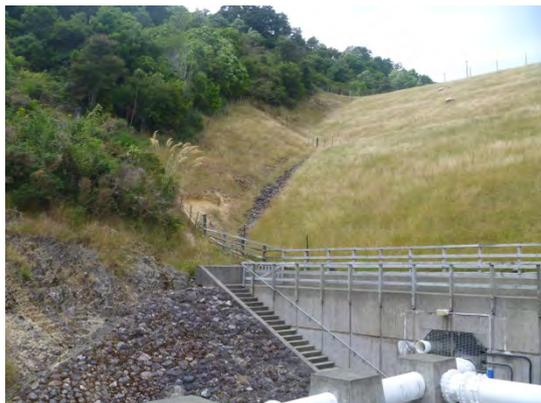
Photo 13: Right Abutment Groin and Culvert area Pipeworks

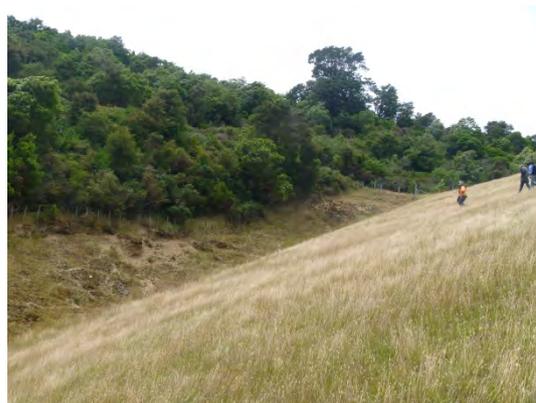
Photo 14: Right Abutment Groin and Overview of Slip Area

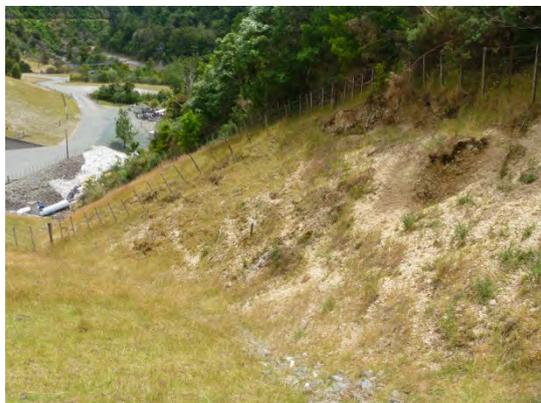
Photo 15: Right Abutment Slip Area

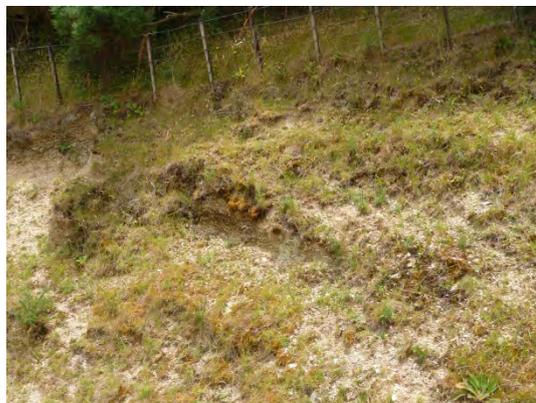
Photo 16: Right Abutment Slip Area

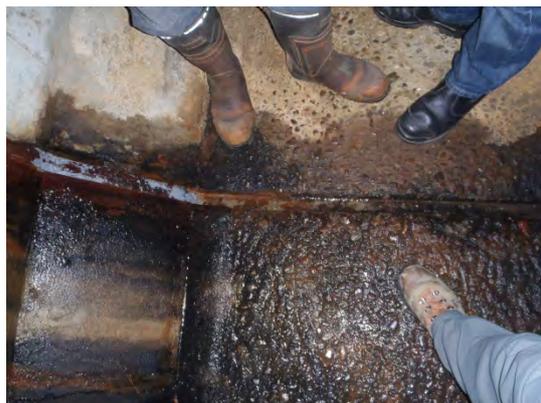
Photo 17: Culvert Bay Joint

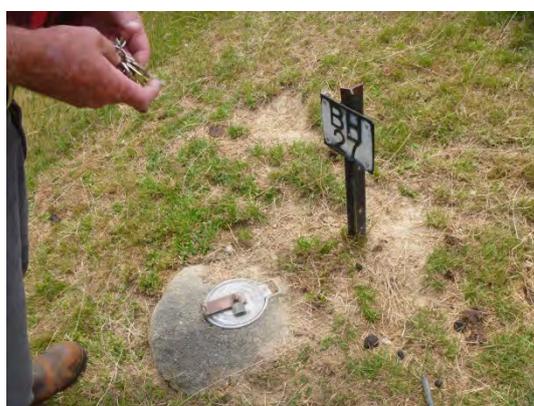
| Item | Comments/Action Required |
|--|--|
| <p>Embankment and abutment standpipe piezometers</p> | <p>Surface seal and caps intact in embankment and abutment standpipe piezometers(Photo 22).</p> |

Photo 22: Downstream Slope Open Standpipe Piezometer

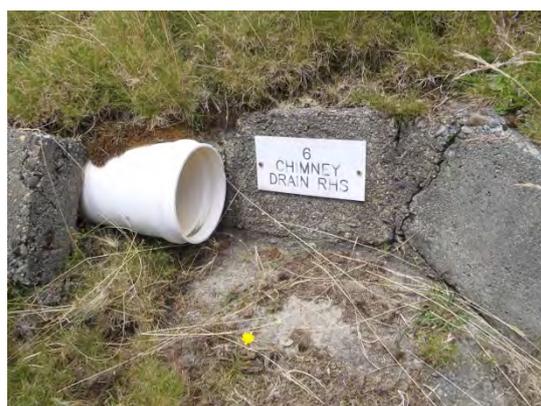
| Item | Comments/Action Required |
|--|--|
| <p>Chimney Drain (R.H.S. & L.H.S.)</p> | <p>No seepage observed emerging from chimney drain, PVC pipe outlet clear of blockage (Photo 23).</p> |

Photo 23 R.H.S. Chimney Drain on Downstream Slope near Abutment

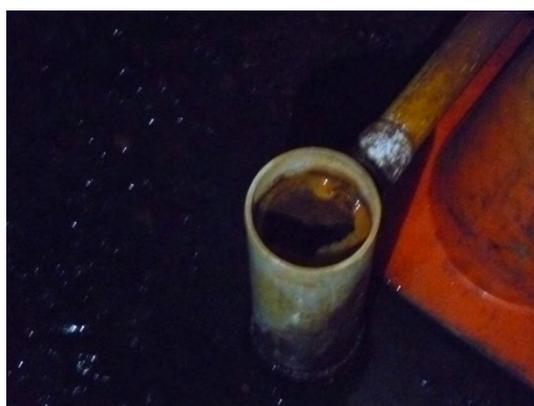
| Item | Comments/Action Required |
|--|--|
| <p>Culvert Interceptor Drain – low flow, consistent with expected</p> | <p>Low and normal clear flow observed from culvert interceptor drain (Photo 24).</p> |

Photo 24: Seepage in Culvert Interceptor Drain

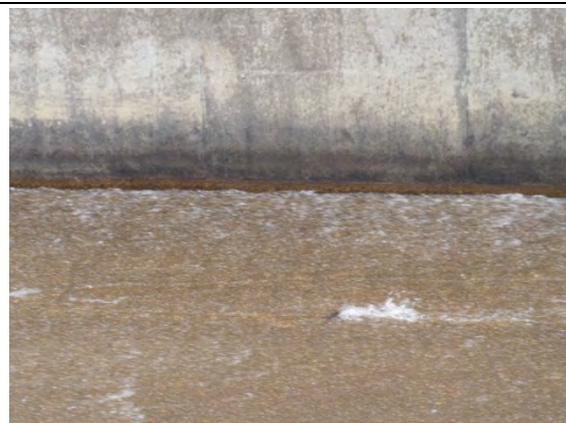
The chute floor has not been specifically analysed, but appears to be conservatively designed. Photographs of the chute floor show turbulent flow over surface cavities and level differences at some floor joints (Photos 27 and 28 in Appendix C). The surface cavities should be repaired to ensure a smooth finish on the chute floor (**repeat Rec-09**).

Photo 28: Service Spillway Floor Rough Surface Area

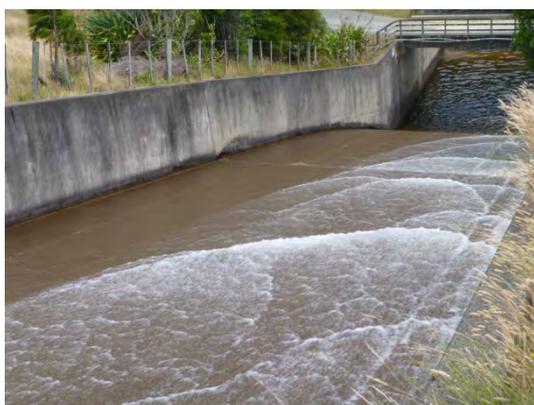
Figure 29: Service Spillway Preferential Flow to Right Side

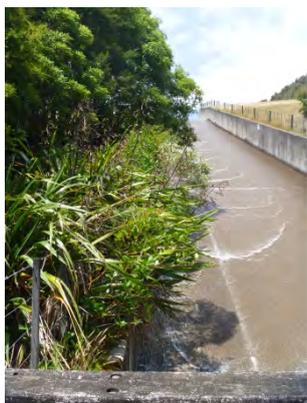
Photo 30: Heavy Vegetation along Right Chute Wall of Service Spillway

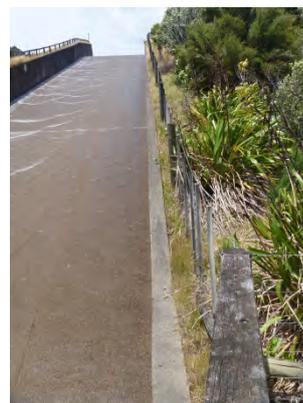
Photo 31: Vegetation along Left Chute Wall of Service Spillway

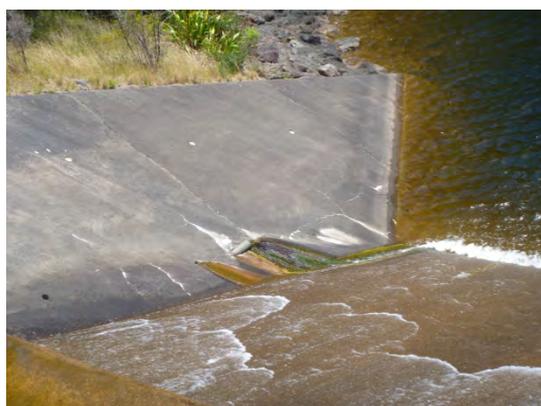
Photo 32: Seepage Emerging for Low Flow Apron

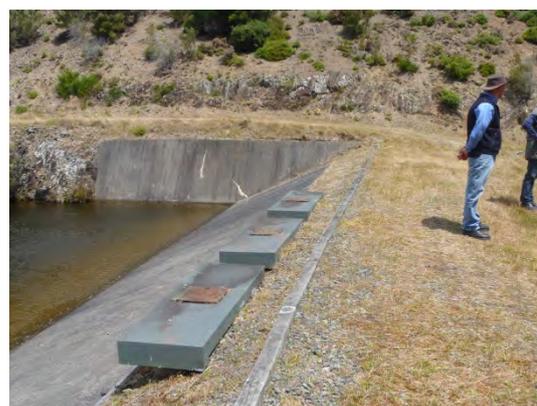
Photo 33: Auxiliary Spillway Upstream Face and Crest with Triggering Troughs

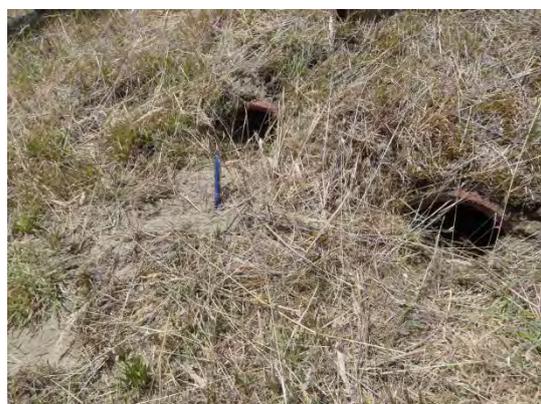
Photo 34: Auxiliary Spillway Downstream Triggering Clay Tile Pipe Outlets

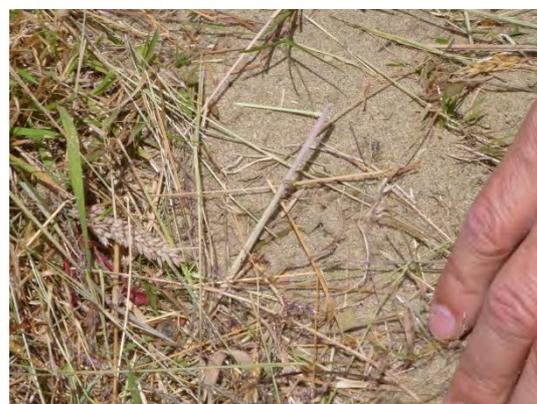
Photo 35: Auxiliary Spillway Downstream Erodible Sand Embankment

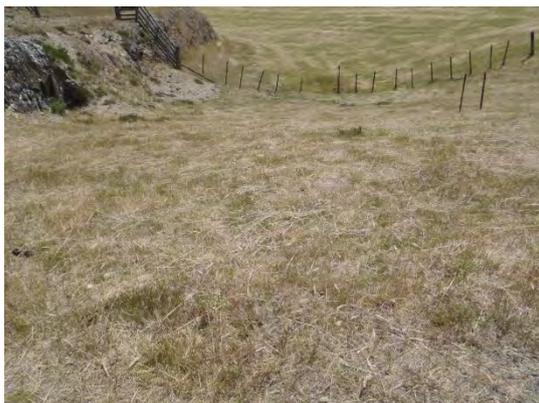
| Item | Comments/Action Required |
|---|---|
| <p>6. Auxiliary Spillway (Fuse Plug)</p> <p>Inspect:</p> <ul style="list-style-type: none"> - Upstream concrete for damage, cracking and spall -Upstream slope, drainage gravel - Crest and Fuse Triggering Troughs for damage, blockage, cracking, - Downstream slope and outlets for vegetation, soil over-compaction, damage, blockage | <p>Upstream concrete face and walls in good condition, minor cracking. (Photo 33).</p> <p>Upstream and crest drainage gravel intact with no deformations or erosion observed. (Photo 33).</p> <p>Fuse triggering troughs intact with no damage, minor rust on cover plates.</p> <p>Downstream sand embankment is clean and maintained in a satisfactory consistency to collapse under fusing (Photos 34 and 35). The V-shaped channel was clear of debris for no blockage during potential fuse plug flows and includes exposed bedrock on left side (Photo 36). Observed normal seepage conditions at downstream toe of sand embankment (Photo 37)</p> |

**Photo 36: Auxiliary Spillway Downstream
V-shape Channel**

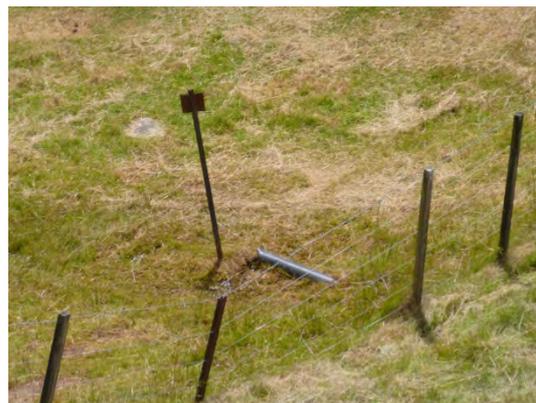
**Photo 37: Downstream Toe of Auxiliary
Spillway with Seepage**

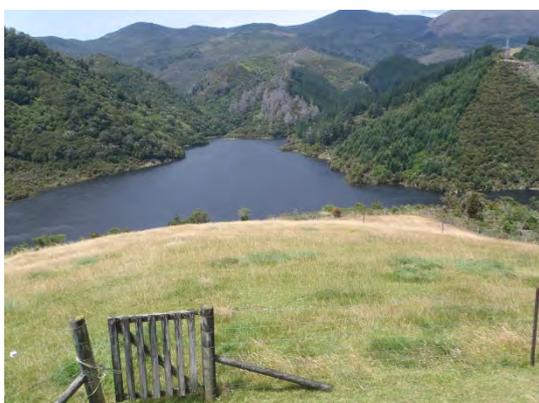
| Item | Comments/Action Required |
|---|---|
| <p>7. Reservoir Area and Perimeter:</p> <ul style="list-style-type: none"> - Inspect shorelines for slips, slope movement, erosion | <p>Forestry plantation observed along southern rim with vegetation buffer provided (Photos 38 and 39).</p> <p>The shoreline includes three historic relatively stable slips with only minor sloughing of colluvium observed (Photos 40 and 41).</p> |

Photo 38: Overview of Maitai Reservoir

**Photo 39: Maitai Reservoir with Forestry
Plantation**

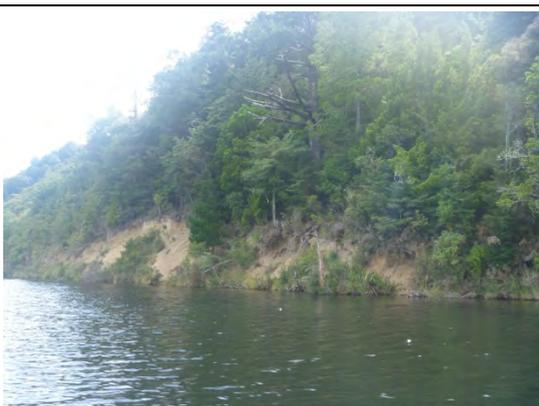
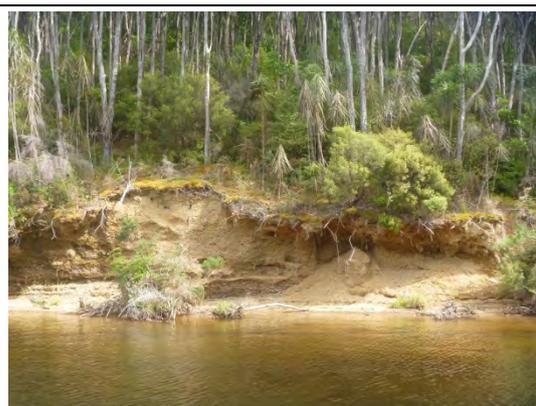
**Photo 40: Maitai Reservoir Slips along
Rim**

**Photo 41: Maitai Reservoir Slips along
Rim**

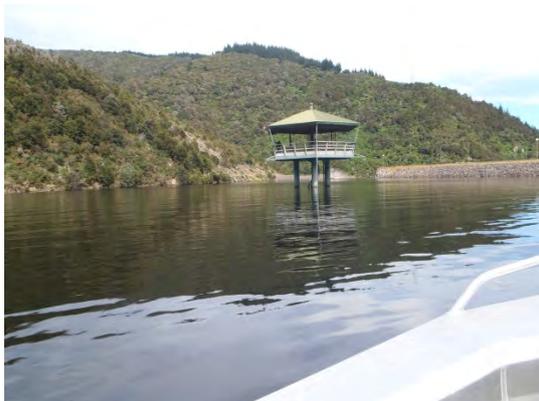
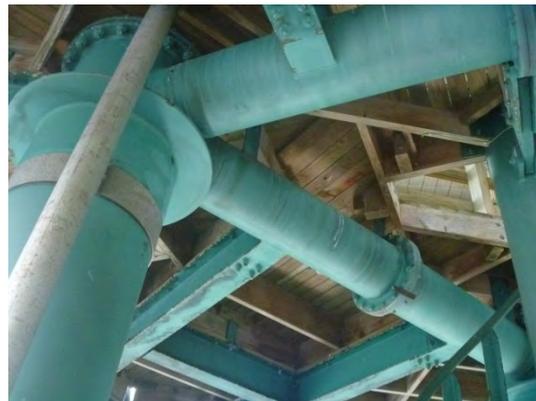
| Item | Comments/Action Required |
|---|---|
| <p>8. Water Supply Intake Tower/General</p> <ul style="list-style-type: none"> - Steel pipes (above water level). -Screen hoisting equipment - Condition of cathodic protection | <p>Steel pipe observed above water in good condition and maintained with paint coverage (Photos 42 and 43).</p> <p>Screen hoisting wench missing at one intake (Photo 44).</p> <p>Recent cathodic protection maintenance providing readings within expected levels compared to 2013 intermediate inspection. Current readings were a voltage reading of ~29 V and current meter reading 2amps (Photo 45).</p> |

Photo 42: Maitai Reservoir and Intake Pipe Tower

Photo 43: Pipework Below Platform of Intake Tower

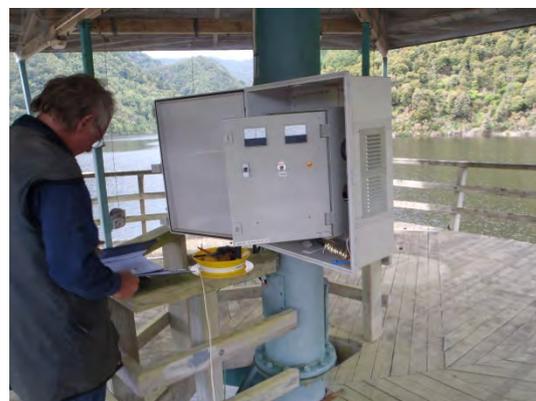
Photo 45: Electrical Panel and Gauges for Cathodic Protection for Intake Tower

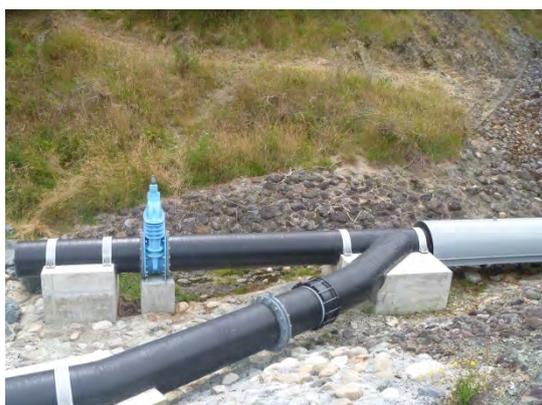
Photo 46: New Duplicate Water Supply Line and Discharge Valve

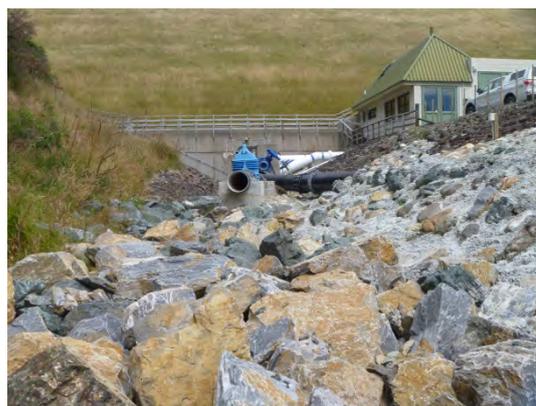
| Item | Comments/Action Required |
|---|---|
| <p>8. Dam Safety Critical Plant</p> <ul style="list-style-type: none"> - Water supply line valve, check valve operations over full range - Bypass scour valve, check valve operations over full range | <p>No operation of water supply or scour valves were performed as part of the CSR inspection.</p> <p>New duplicate water supply line observed at downstream end of culvert area. New section includes capability to make temporary releases to the stream channel (Photos 46 and 47).</p> <p>Rip-rap protection in channel in good condition and recently upgraded with larger stone (Photo 47)</p> |

Photo 47: Reinforced Rip-rap Placed in Discharge Area of Water Supply Line and Scour
